**Flood Control Project Maintenance  
Levee Inspections**

**Fall 2013 Levee Maintenance Deficiency Summary Report**

**Sutter Maintenance Yard Nelson Bend**

Waterway			Bank	Unit Miles
Unit No. 01 Feather River West Levee-Nelson Bend				0.50
	Spring (March - May)	Summer (June - August)	(September - November) Fall	Winter (December - February)
Unit Maintenance Rating (Fall Only)			<b>U</b>	
Date of Inspection	05/10/2013 - 05/10/2013		10/22/2013 - 10/22/2013	
DWR Inspector	Bob Duffey		Matthew Hoffman	
Accompanied By

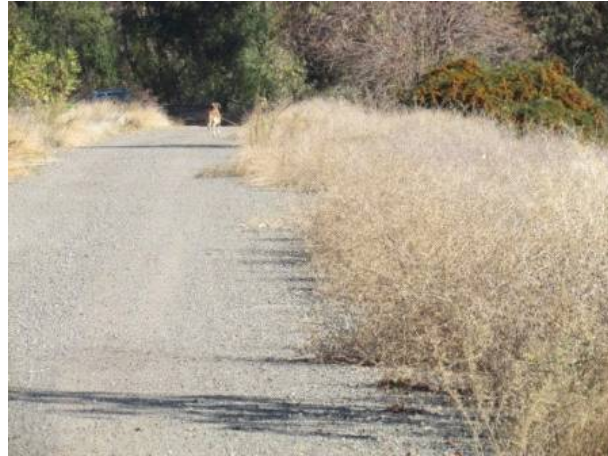
Levee Mile Report Line	2
Start Levee Mile	0.01
End Levee Mile	0.45
Location	Land Side
Category	Earthen Levee
Item	Vegetation

This photo was taken at levee mile 0.10 looking upstream at the waterward vegetation.

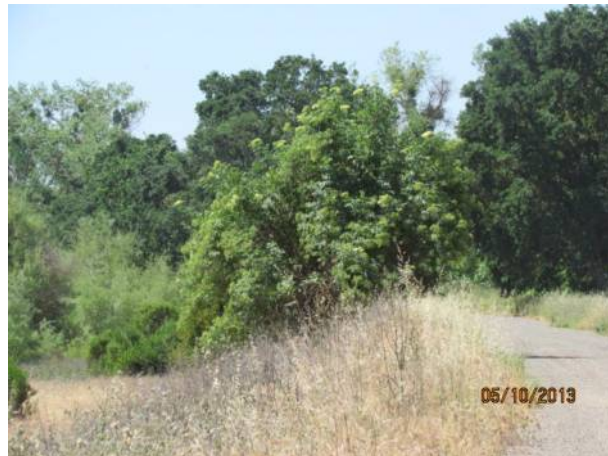
Levee Mile Report Line	4
Start Levee Mile	0.05
End Levee Mile	0.05
Location	Water Side
Category	Earthen Levee
Item	Vegetation

View of the elderberries that are blocking visibility.
